Technical Report CERC-96-8
September 1996

Periodic Inspection of Burns Harbor North Breakwater, Indiana

Report 1 Base Conditions

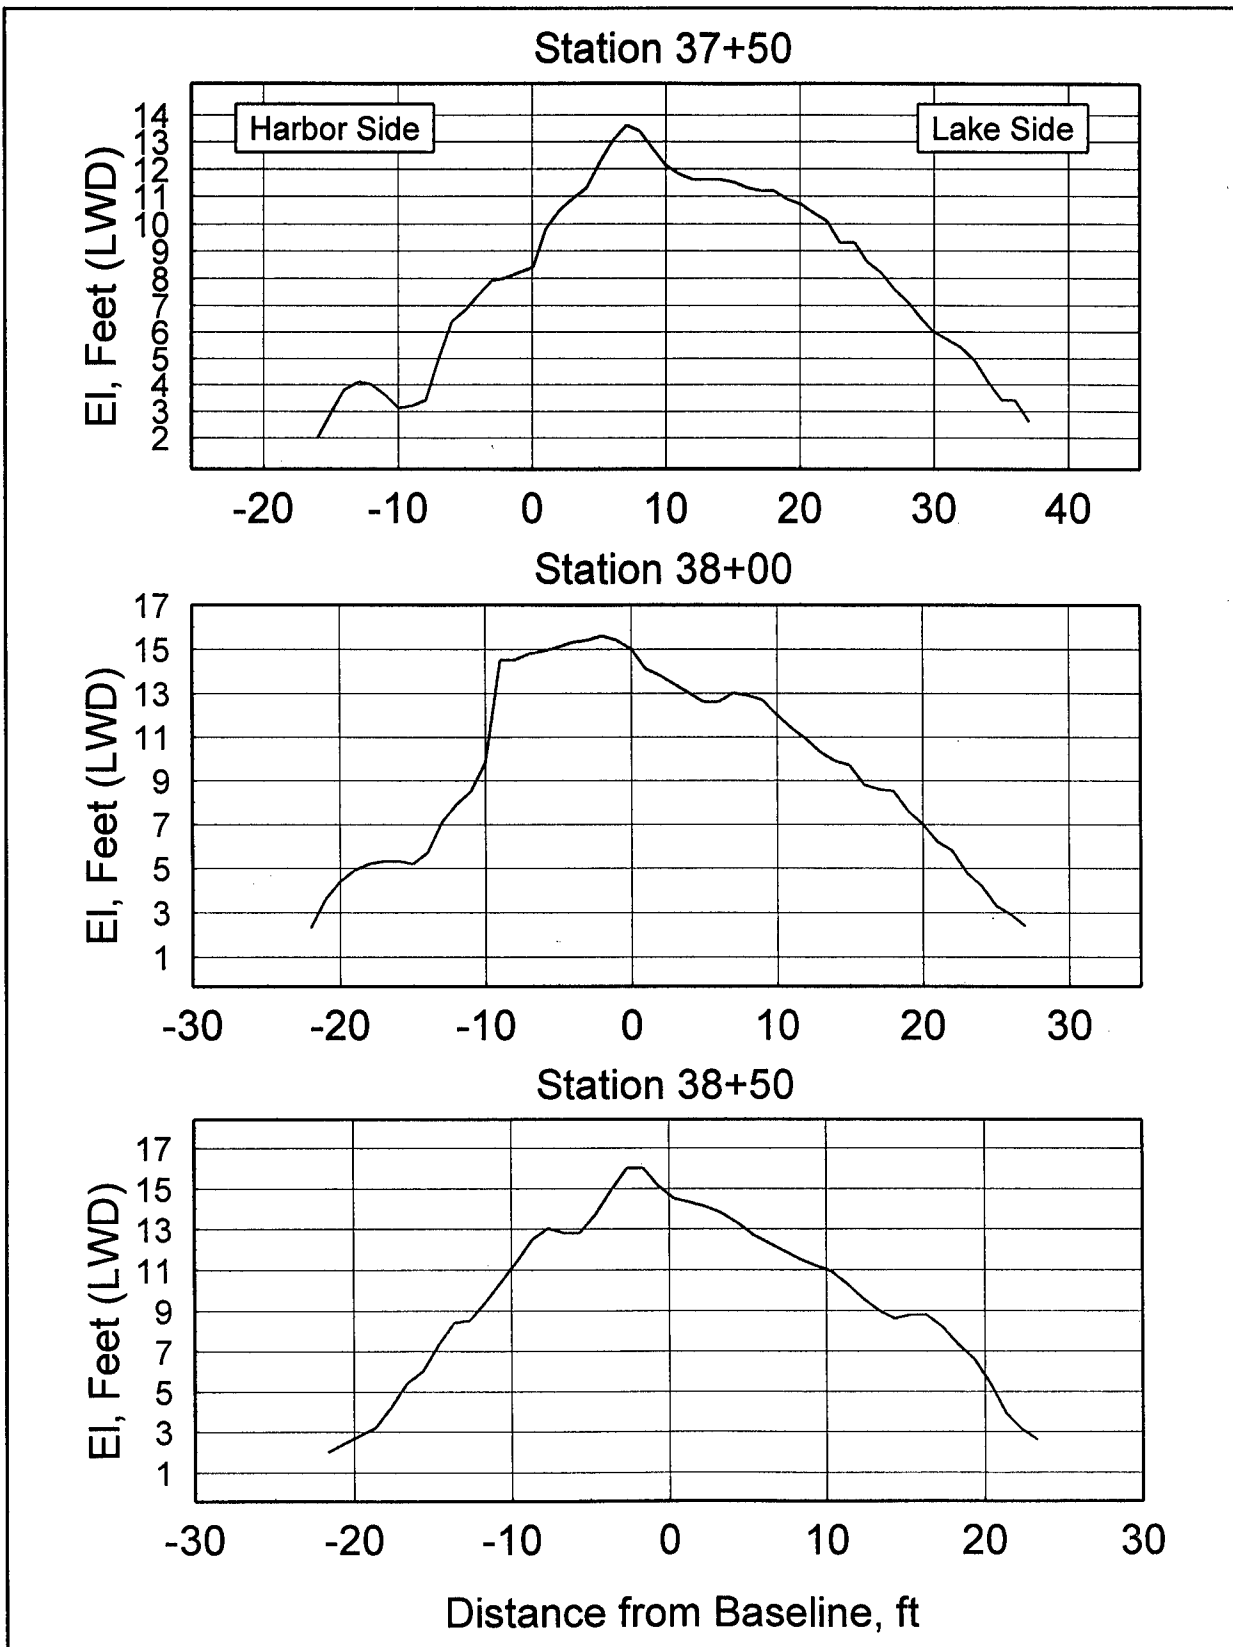
Figure B30. Cross sections of Burns Harbor North Breakwater, sta 37+50, 38+00, and 38+50

This appendix presents cross sections of the Burns Harbor North Breakwater. Cross sections were developed using the digital terrain model (DTM) grid as stated in the main text of this report. They were obtained at 0.3-rad (15-deg) intervals around the head of the breakwater and 15.2-m (50-ft) intervals along the trunk as shown in Figure 10 in the main text of this report. Elevations shown are in feet referred to low water datum (lwd). To convert them to meters, multiply by 0.3048. Distances from the baseline also are shown in feet and may be converted to meters using the same factor. The baseline established was the approximate center line of the breakwater. Negative distances are measured relative to the harbor side of the baseline and positive distances are measured relative to the lake side of the baseline.

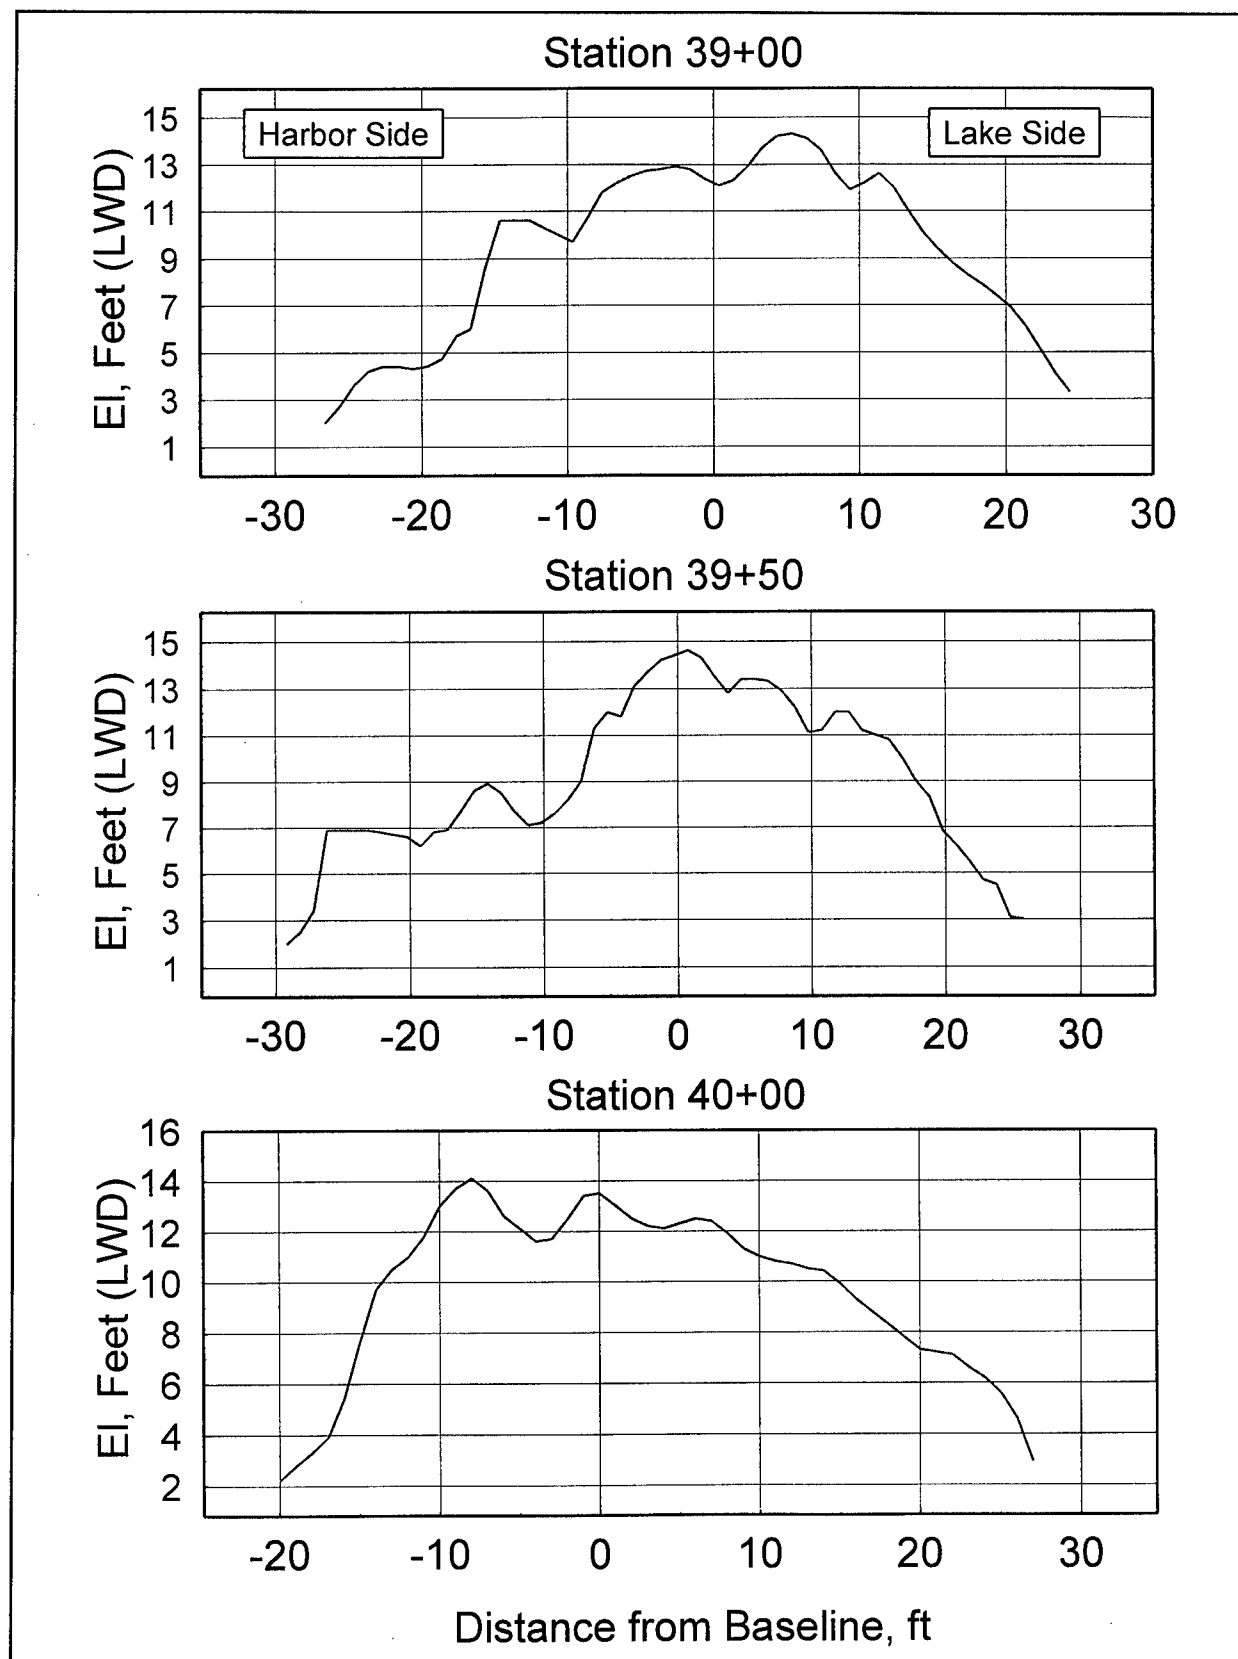
Figure B31. Cross sections of Burns Harbor North Breakwater, sta 39+00, 39+50, and 40+00

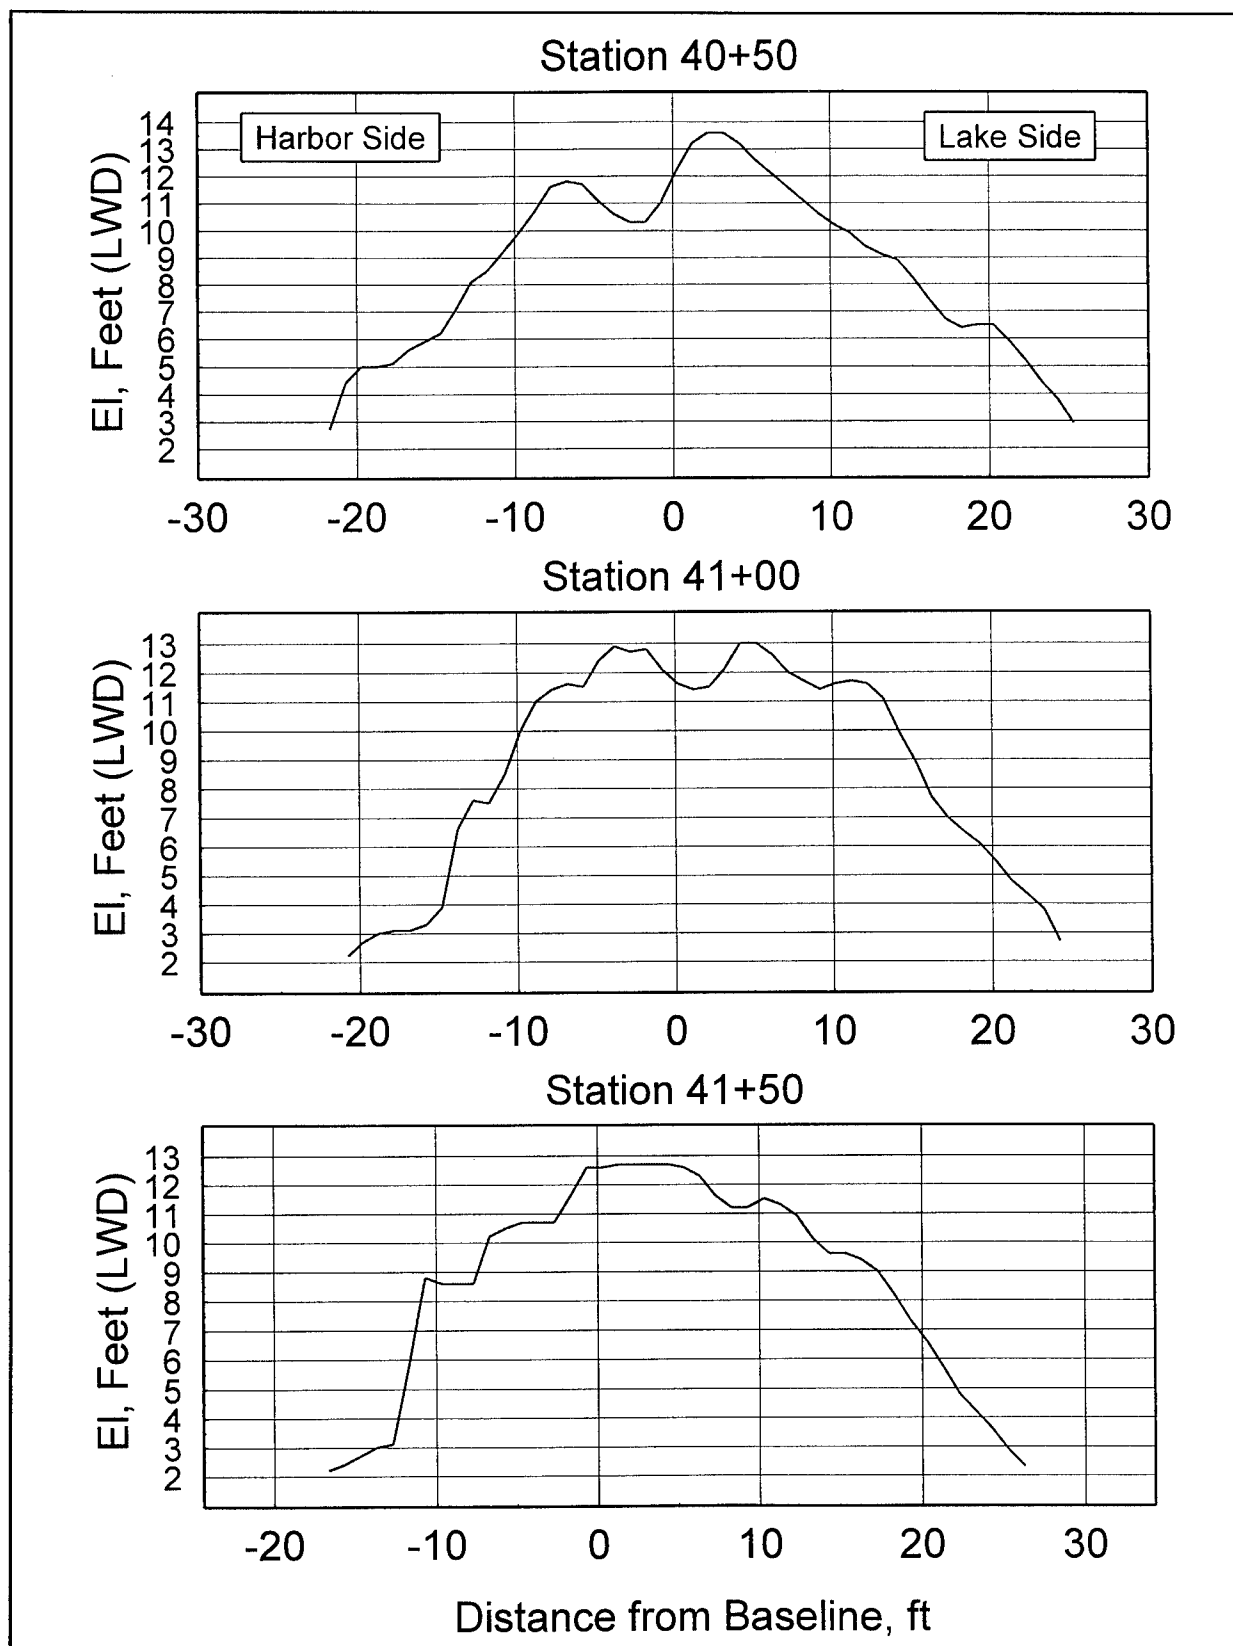
Figure B32. Cross sections of Burns Harbor North Breakwater, sta 40+50, 41+00, and 41+50

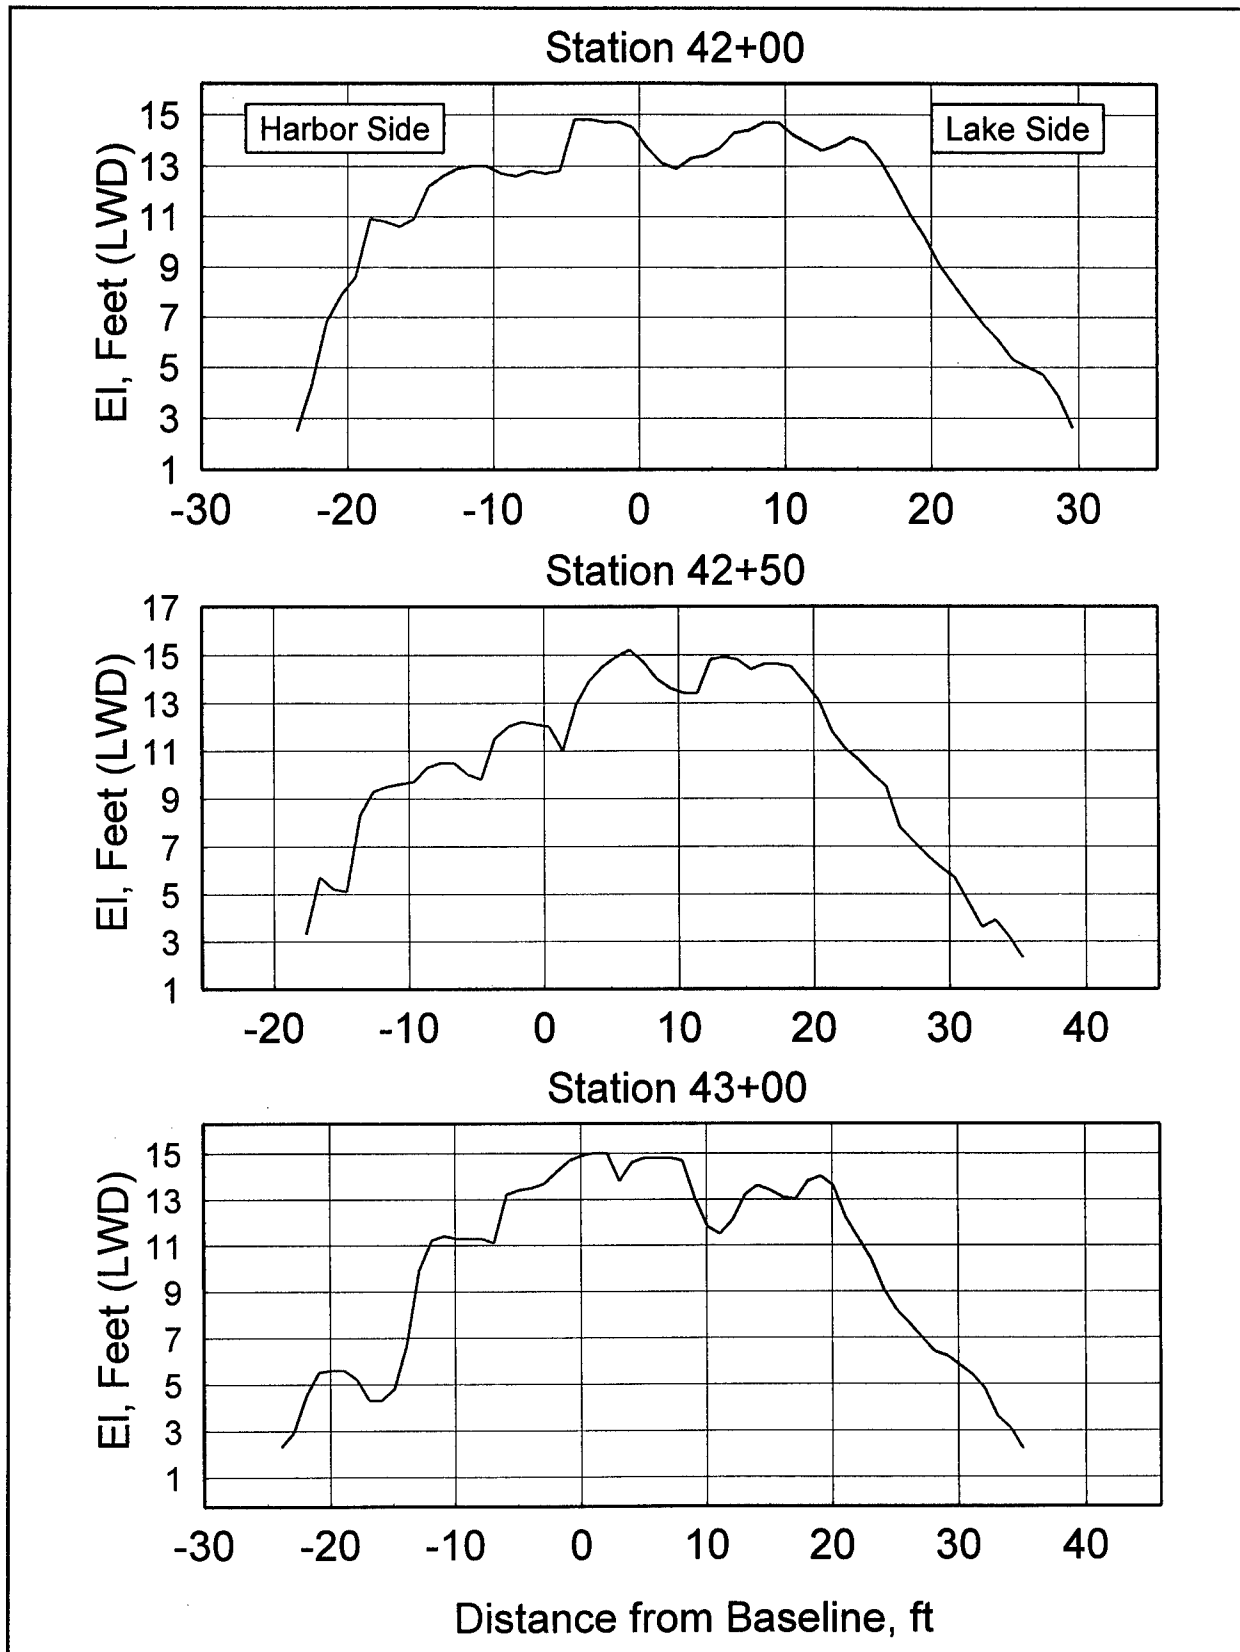
Figure B33. Cross sections of Burns Harbor North Breakwater, sta 42+00, 42+50, and 43+00

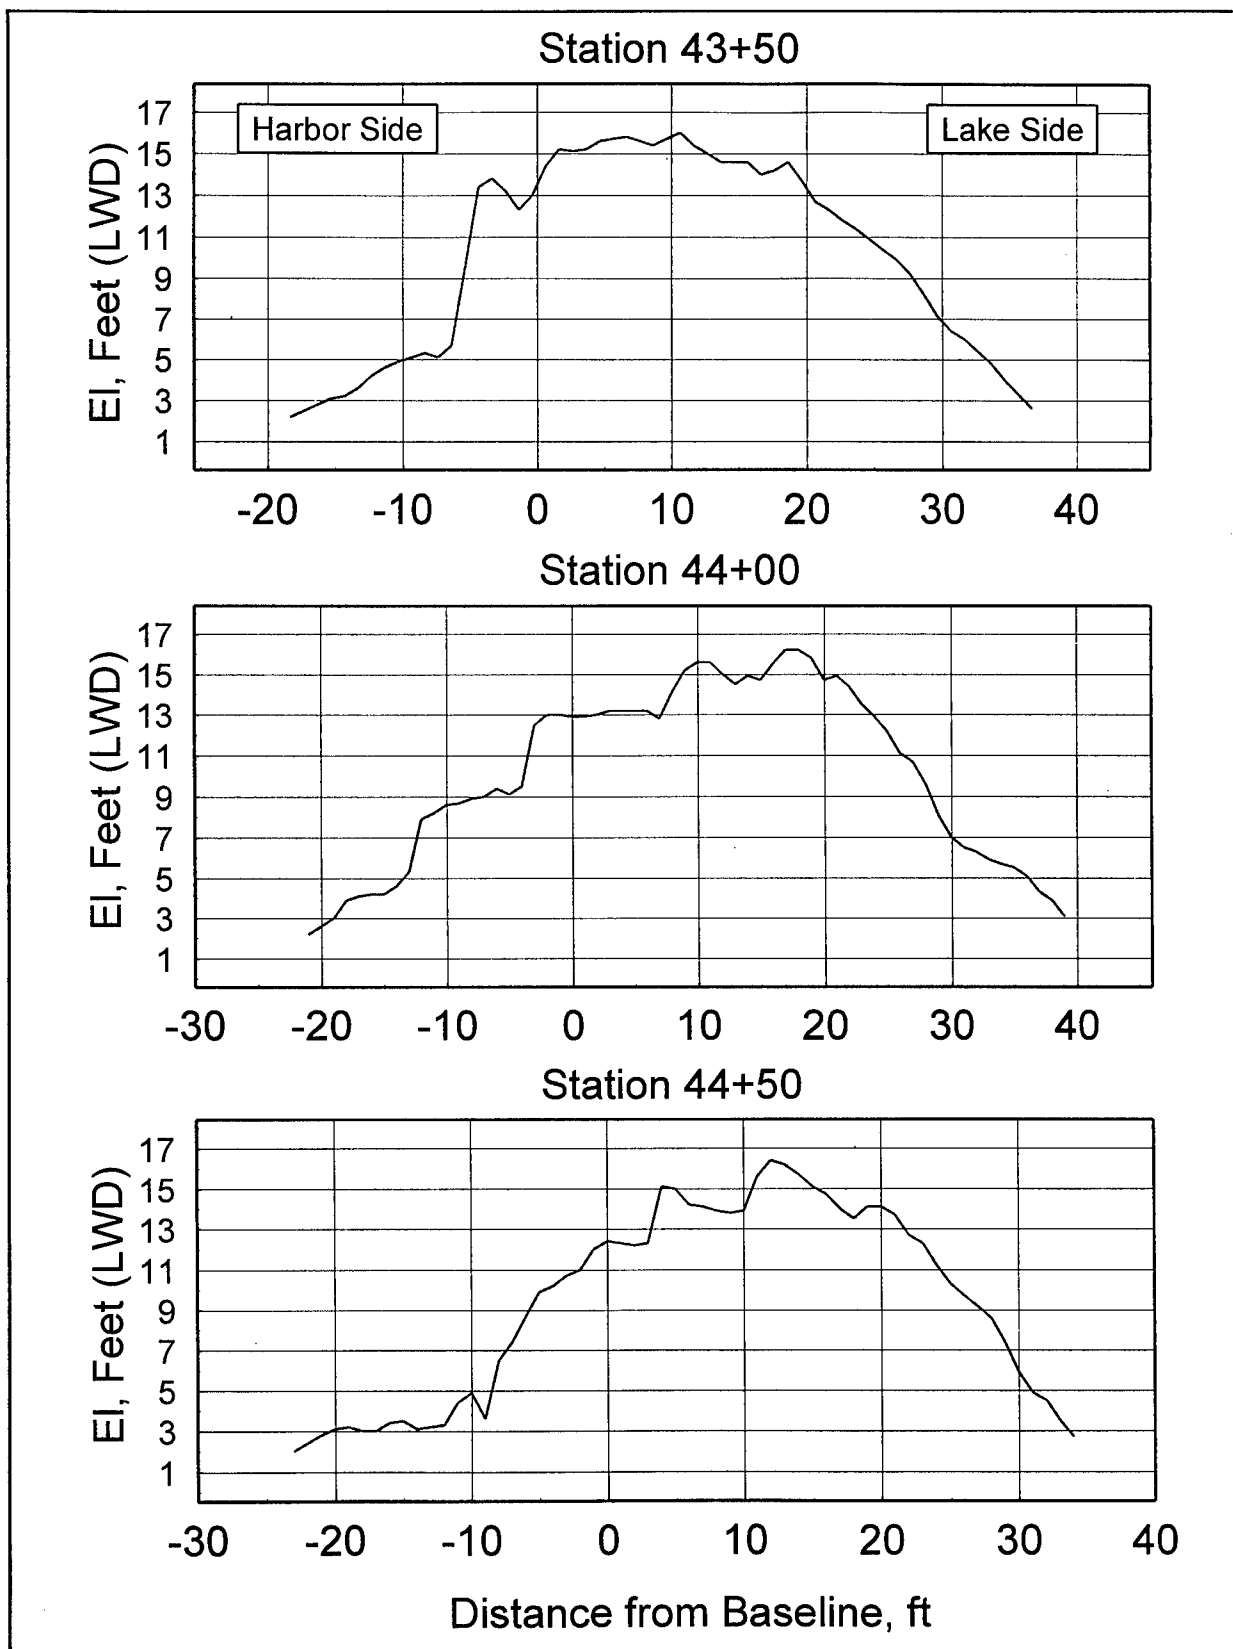
Figure B34. Cross sections of Burns Harbor North Breakwater, sta 43+50, 44+00, and 44+50

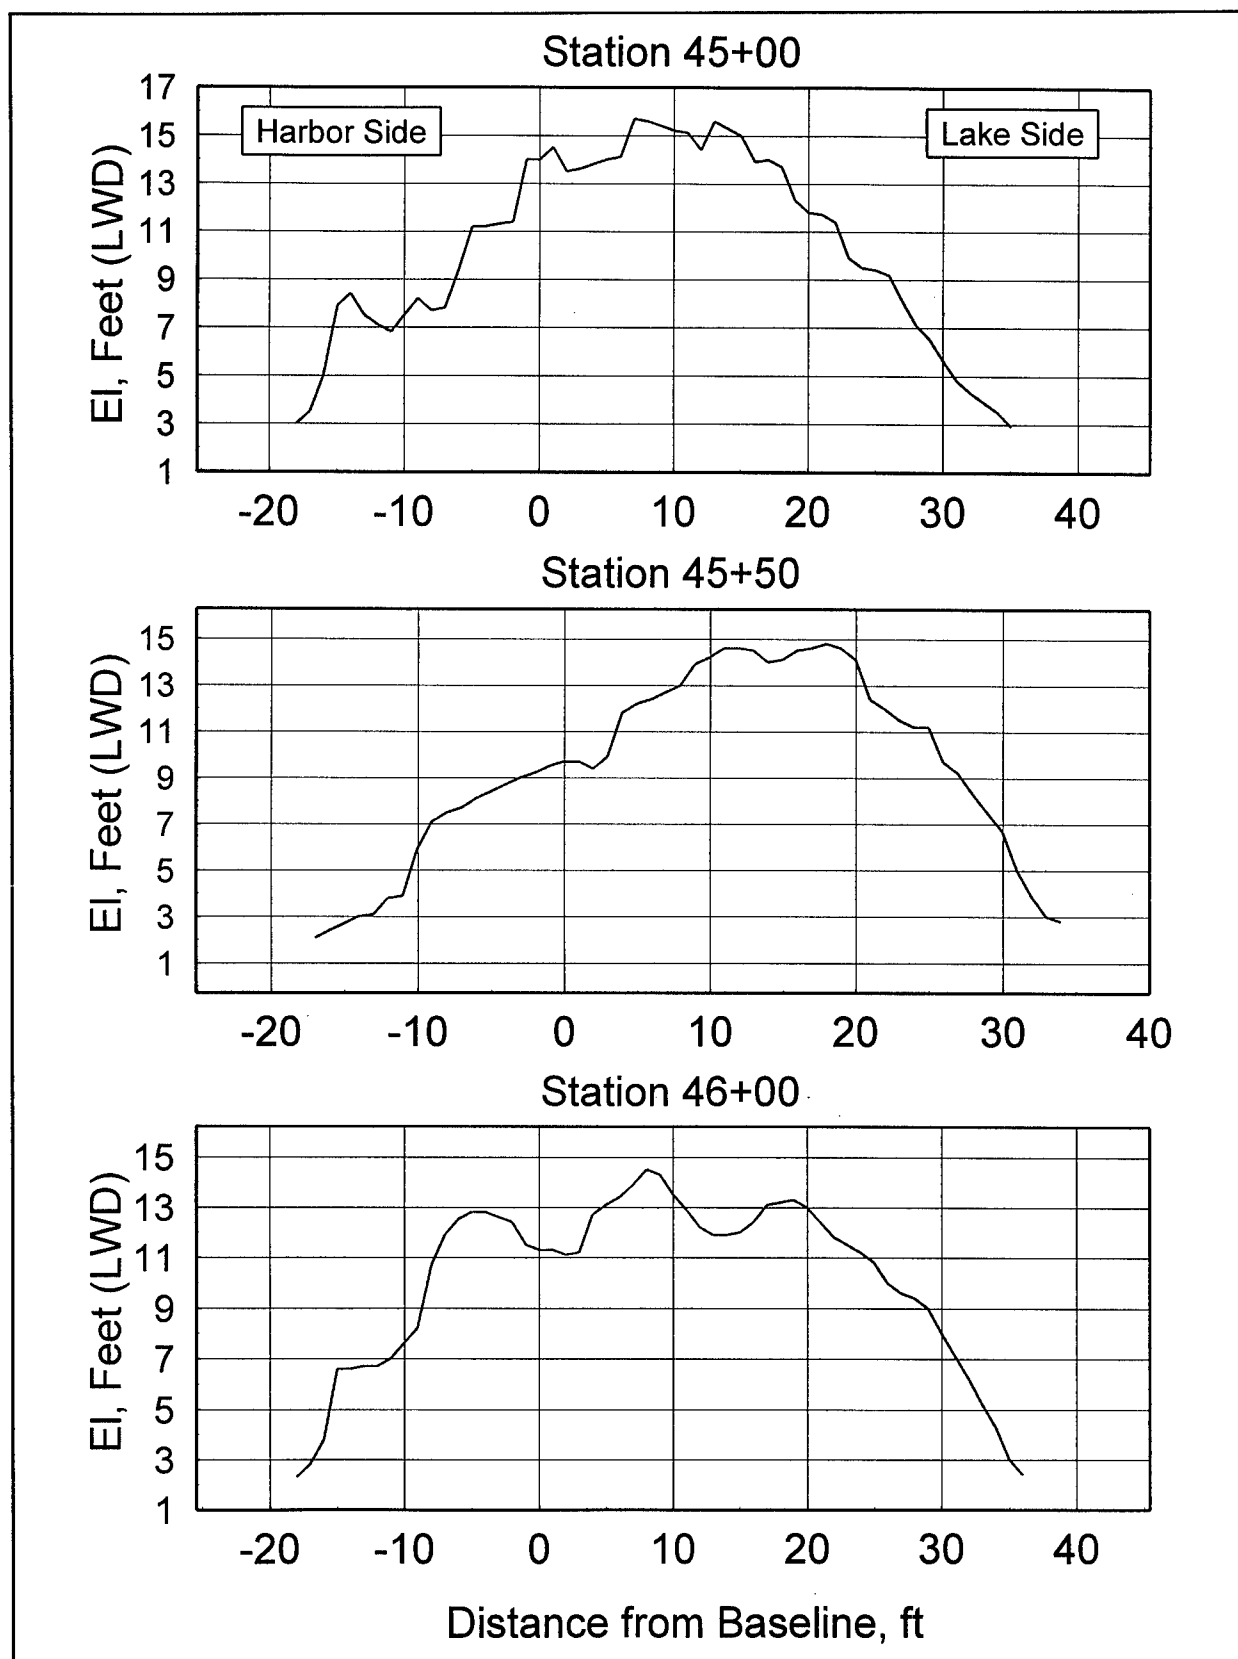
Figure B35. Cross sections of Burns Harbor North Breakwater, sta 45+00, 45+50, and 46+00

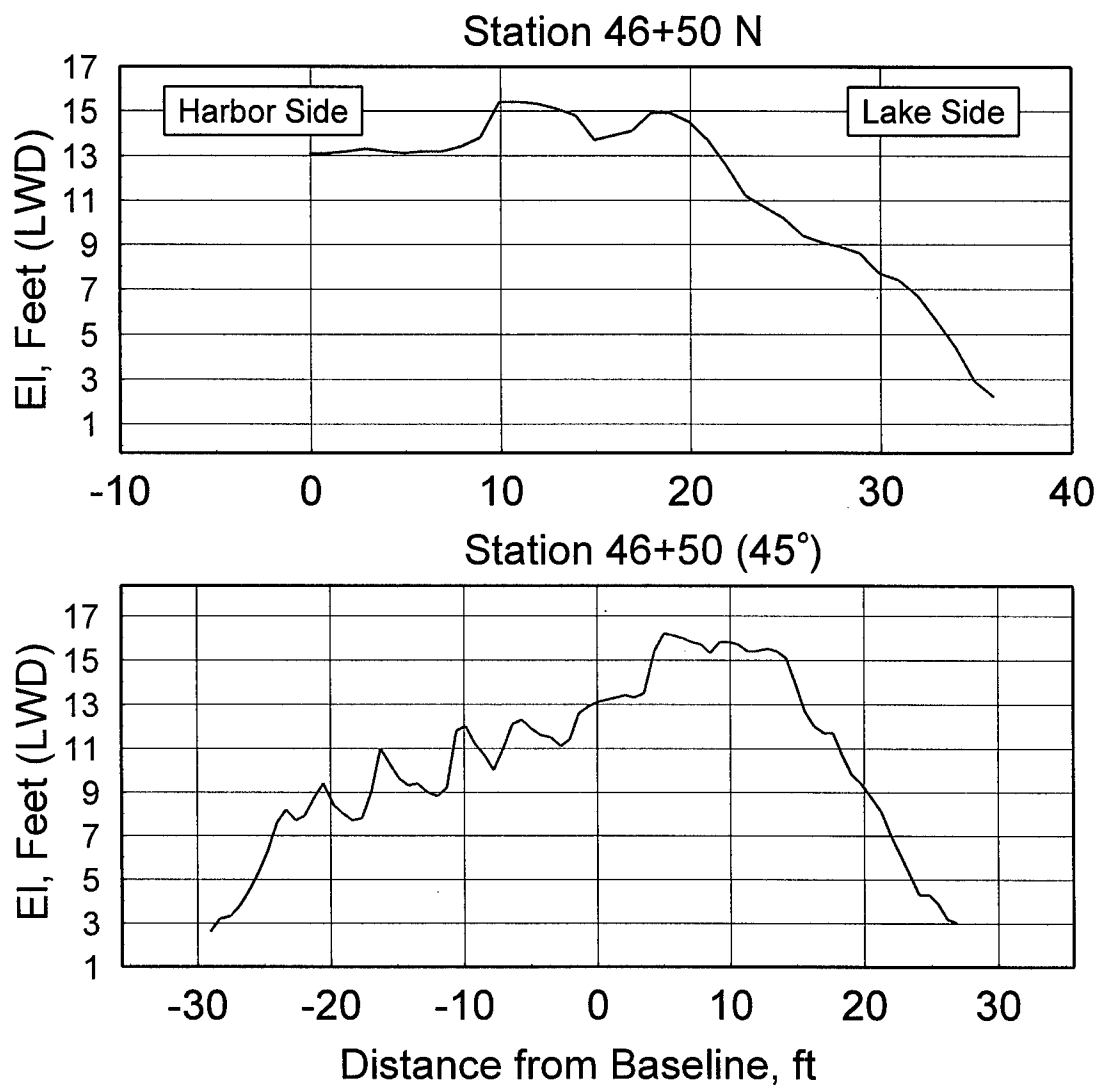
Figure B36. Cross sections of Burns Harbor North Breakwater, sta 46+50 N and 45+50 (0.8 rad (45 deg))
